## **Design of an Occupational Safety and Health (OSH) at the Vocational School's Laboratory of Gadjah Mada University, Yogyakarta**

Universitas Gadjah Mada, Indonesia

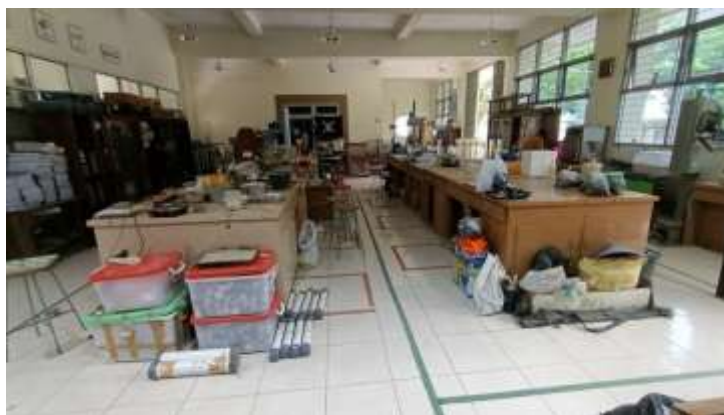
Figure 1. Soil Mechanics Laboratory

The Soil Mechanics Laboratory is used for testing moisture content, specific gravity, melt limits, plasticity limits and indexes, limits and shrinkage factors, grain size distribution, and soil compaction, with potential hazards in the form of dust exposure, use of mechanical tools, heavy loads, and electrical risks from supporting equipment. In terms of workplace visuals, PPE posters have been installed on the laboratory wall, but floor markings are only found around the workbench used to implement social distancing during the Covid-19 pandemic, while the area around risky instruments such as drying ovens has not been marked or warning signs of heat and electricity hazards. In the aspect of fire management, the results of the calculation of fire extinguishing needs based on a room area of 270 square meters show the need for 2 units, while the available only 1 unit of dry chemical powder, is placed next to the door with the top of the fire extinguisher 165 centimeters from the floor without a marker sign on it, and the last maintenance date was recorded on October 21, 2024 even though the pressure indicator is still in the green zone. The P3K box was found in the work area in the form of a wooden cabinet with dirty and stained surface conditions, had a red cross symbol but without type identification or a content checklist on the inside of the box, with contents consisting of only a few liquid drugs and sanitary napkin gauze without a clear grouping. For PPE, it is recorded that 8 pairs of safety shoes, 12 work gloves, 300 masks, 2 protective glasses, and 35 safety helmets are available, with laboratory coats and closed shoes that are required before the practicum takes place.

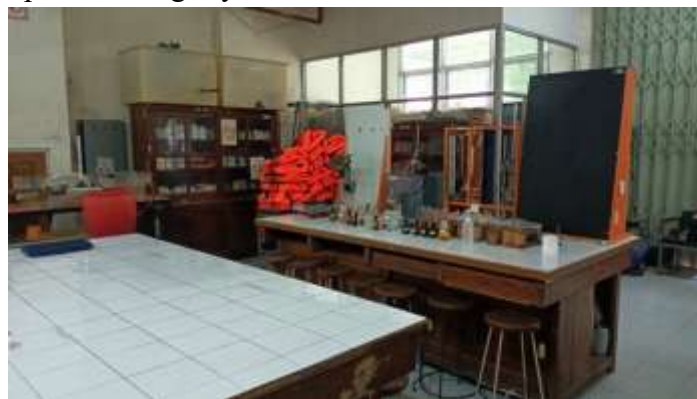
Figure 2. Environmental Engineering Laboratory

Environmental Engineering Laboratories are used for environmental quality testing and the use of certain chemicals, with potential hazards in the form of exposure to chemicals and the use of electrical equipment such as aeration, sedimentation, hot plates, and ovens. A large number of PPE posters and signs prohibiting smoking and mixing chemicals without labels have been installed, but floor markings for hazardous areas have not been implemented, and warning signs on several instruments such as acid cabinets, filter columns, sedimentation apparatus, permeability and fluidisation apparatus, and hot plates have not been consistently installed even though the ion exchange apparatus has been equipped with corrosive material signs. The need for fire extinguishers based on an area of 110.25 square meters is 1 unit and has been available, but it is placed with a fire extinguisher peak of 179 centimeters from the floor without signs, with the last maintenance recorded on October 21, 2024. The P3K box is available on the instrument table in a plastic cabinet in good condition but without type labels or checklists, with contents in the form of liquid medicines, bandage gauze, quick wound plaster, eye drops, iodine, counterpain ointment, as well as some additional drugs such as entrostop, paracetamol, and oralit that are not actually mandatory. The PPE available is only an orange safety vest in sufficient quantities for one practicum session, stored in a stacked condition without a special storage system.

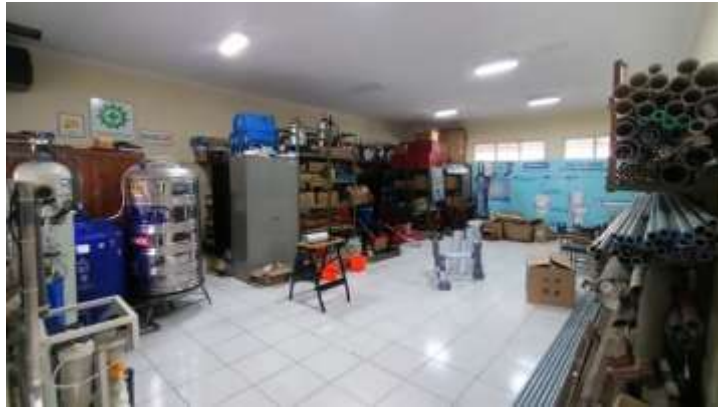
Figure 3. Plumbing Laboratory

The Plumbing Laboratory is used for practicum activities of piping installations and sanitation systems, with potential hazards in the form of pinching, being overtaken, and slipping pipes, slipping due to wet work areas, the use of work tools, and electrical risks from supporting equipment. Visual workplaces in the form of PPE posters for safety helmets and no-smoking signs have been installed, but floor markings for hazardous areas have not been implemented. The need for fire extinguishers based on an area of 90 square meters is 1 unit and is available in dry chemical powder, but placed directly on the corner floor of the room next to the tool cabinet without a marker, with the last maintenance that has passed 6 months even though the pressure is still in the green zone. P3K boxes are not available at all in this laboratory. PPE has also not been provided, students are only required to use laboratory coats and closed shoes during the practicum.

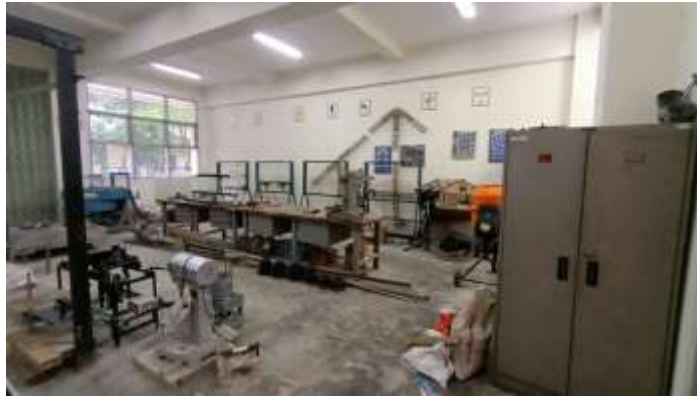
Figure 4. Concrete Structure Laboratory

The Concrete Structure Laboratory is used for testing and practicum related to concrete materials and structural elements, with potential hazards in the form of heavy loads, the use of mechanical test equipment, the risk of physical injury, and noise. The PPE poster which includes safety helmets, wearpacks, safety gloves, safety shoes, safety goggles, masks, and ear muff has been installed quite completely. The need for a fire extinguisher based on an area of 126 square meters is 1 unit and has been available in dry chemical powder, placed on the wall next to the main door with a height of 160 centimeters from the floor without a marker, with the last maintenance that has also passed 6 months. The P3K box is available on the wall near the main door in good condition and neatly arranged, easy to identify, reach, and view, with relatively better completeness than other laboratories although it still needs improvement. The PPE available includes a large number of masks and safety gloves, several units of full body harnesses, and several ear muffs that can be used by students.

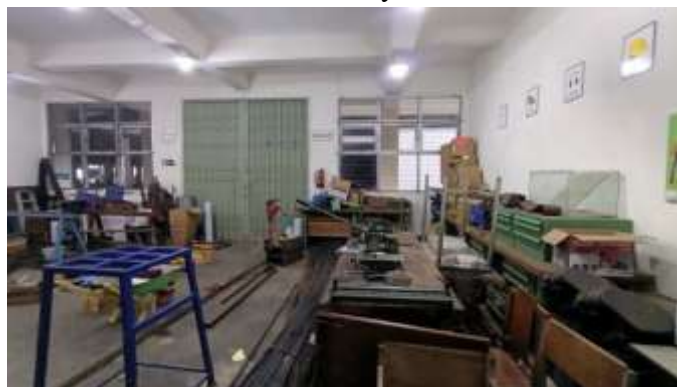
Figure 5. Steel Structure Laboratory

The Steel Structure Laboratory is used for practicum involving metal materials and testing of steel structural elements, with potential hazards in the form of cuts, material impacts, mechanical risks, and electricity. The PPE poster and the appropriate tool use procedure signs have been installed quite complete. The need for fire extinguishers based on an area of 126 square meters is 1 unit and is available in dry chemical powder, placed on the wall next to the main door with a height of 165 centimeters from the floor without a sign. The P3K box is available on the wall near the main door in good condition and neatly arranged, with relatively better equipment than other laboratories. For PPE, only a small number of safety gloves were found for one practicum session, with no special storage, while potential hazards such as cutting sparks, metal dust, and noise were not fully covered.

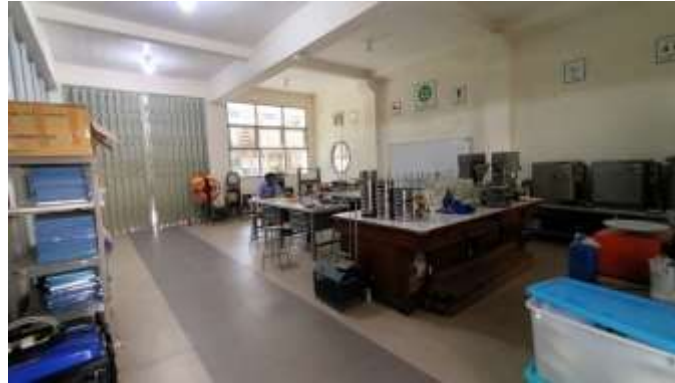
Figure 6. Building Materials Laboratory

The Building Materials Laboratory is used for testing various types of construction materials using laboratory test equipment, with potential hazards in the form of dust, the use of test equipment, the potential for minor injury, and potential noise. The PPE poster that includes safety helmets, wearpacks, safety gloves, safety shoes, and ear muff has been installed quite completely. The need for a fire extinguisher based on an area of 110.25 square meters is 1 unit and has been available, placed on the wall next to the main door with a height of 180 centimeters from the floor without a marker, with the last maintenance that has also passed 6 months. The P3K box was found on the wall near the main door in the form of a wooden cabinet with dirty and stained surfaces, had the symbol of the red cross but the contents were only liquid medicine, bandage gauze, and quick wound plaster. The PPE available is in the form of

yellow safety vests and safety helmets with enough for one practicum session, but the safety vest storage is still in an open condition.

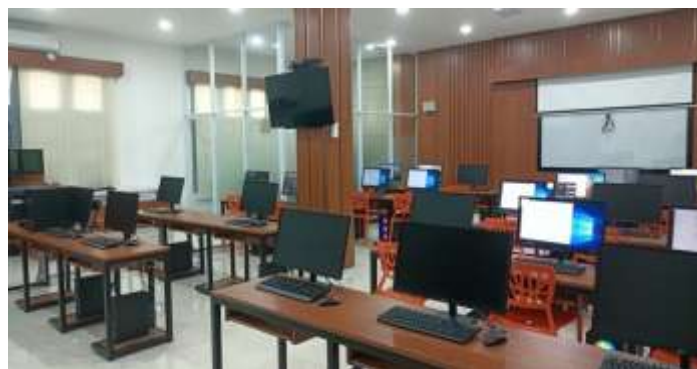
Figure 7. Technology, Applications, and Network Laboratories

The Technology, Applications, and Network Laboratory is used for practicum activities related to the use of computers, network devices, and low-voltage electrical installations, with potential hazards in the form of the risk of mild electric shock, overheating of the device, improper wiring, and ergonomic risks due to prolonged use of computers. The observation results showed that there was no visual workplace in the form of electrical hazard signs, cable line markings, and network equipment identification labels, so not all users or laboratory visitors knew about the potential dangers that existed. The need for fire extinguishers based on an area of 105 square meters is 1 unit, but there is no fire extinguisher available at all in this laboratory. P3K boxes are also not yet available, although practicum activities still have potential dangers in the form of minor injuries due to electrical equipment and network cables, scratches during device installation, and health problems such as eye irritation and work fatigue.

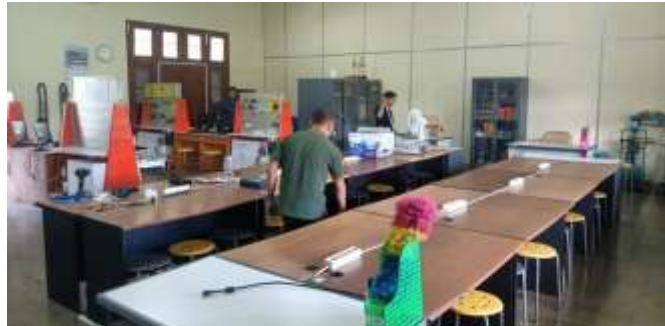
Figure 8. Instrumentation and Control Laboratory

The Instrumentation and Control Laboratory is used for practicum involving sensors, actuators, control panels, and automation systems, with potential hazards in the form of electric shock, short circuits, and equipment misoperation. There is no visual workplace in the form of electrical hazard signs and equipment identification labels, just like the conditions in the

Technology, Application, and Network Laboratory. The need for fire extinguishers based on an area of 100 square meters is 1 unit, but it is not yet available. P3K boxes are also not yet available, as well as Personal Protective Equipment for laboratory users, although practicum activities involve electrical installation and the assembly process of tools that risk scratches and minor electric shocks.

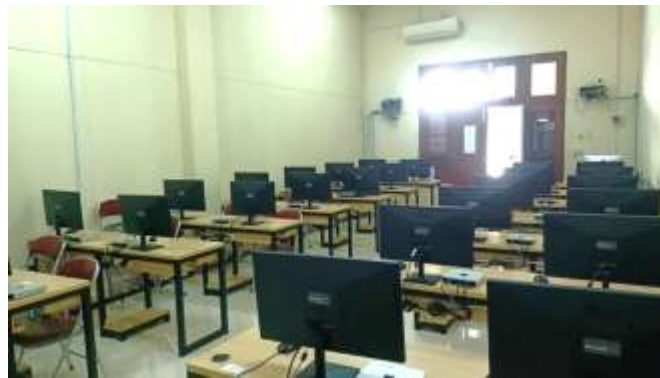
Figure 9. Software Engineering Laboratory

The Software Engineering Laboratory is used for practicum activities for the development and testing of computer-based software, with relatively low risks in the form of ergonomic interference, work fatigue, and electrical risks from computer devices. There is no workplace visual in the form of safety signs or work ergonomics posters. The need for fire extinguishers based on an area of 54.08 square meters is 1 unit, but there are no fire extinguishers available in this laboratory. P3K boxes are also not yet available, although there are still potential hazards in the form of minor injuries due to electrical equipment and network cables as well as health problems such as eye irritation and work fatigue.

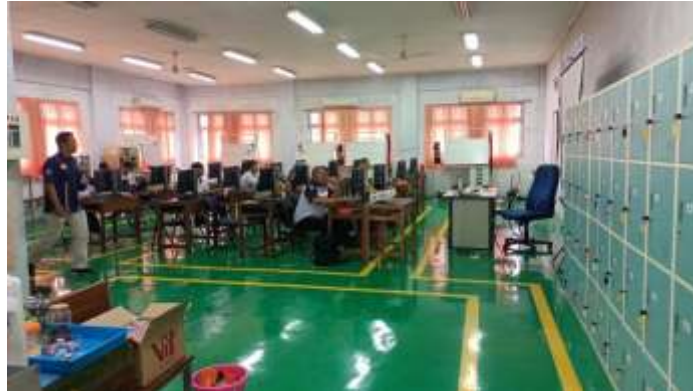
Figure 10. Control and Automation Laboratory

The Control and Automation Laboratory is used for practicum activities related to control systems, sensors, actuators, and electrical-based and pneumatic automation, with potential

hazards in the form of the risk of electric shock, automatic system operation errors, and technical hazards due to the use of panels and work devices. On the laboratory floor, floor marking has been installed in the form of a green safe work area and a yellow safe path. The need for fire extinguishers based on an area of 144 square meters is 1 unit and is available in dry chemical powder, placed on the wall next to the main door with a height of 180 centimeters from the floor without a sign, with the last maintenance recorded on November 7, 2024. The P3K box was found in the form of a wooden cabinet with dirty and stained surface conditions, without a red cross symbol, type identification, or a contents checklist, with only the contents in the form of quick-wound plaster and cotton. PPE is not yet available in this laboratory.

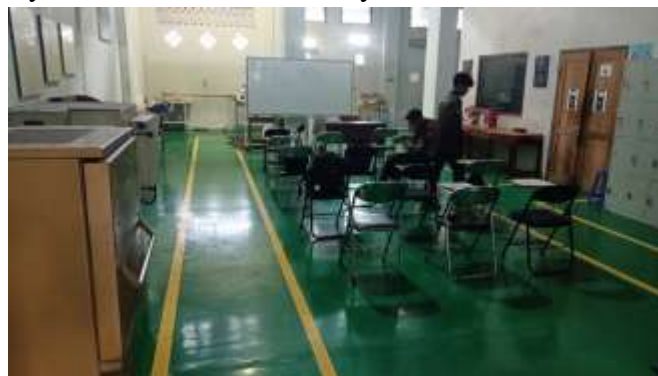
Figure 11. Materials and Production Process Laboratory

The Materials and Production Process Laboratory is used for practicum activities for testing materials and manufacturing processes, with potential hazards in the form of exposure to heat, material debris, noise, and mechanical risks from production equipment. Floor marking has been installed, accompanied by signs of hazardous chemicals, irritants, corrosives, explosives, and oxidizers in the area of storing and using chemicals, equipped with mandatory PPE signs in the form of gloves, masks, and safety glasses. The need for fire extinguishers based on an area of 138.24 square meters is 1 unit and has been available, placed on the wall next to the main door with a height of 180 centimeters from the floor without signage, with the last maintenance recorded on November 7, 2024. The P3K box was found in the form of a wooden cabinet with dirty and stained surfaces, with only the contents of quick-wound plaster and cotton. PPE is not yet available for laboratory users.

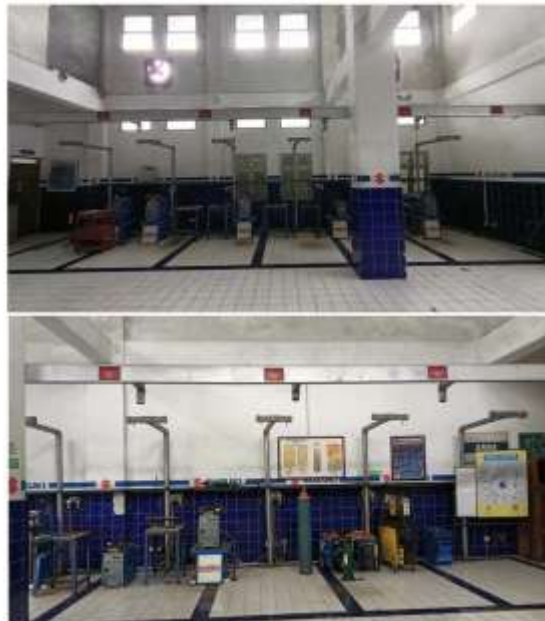
Figure 12. Welding Laboratory

Welding Laboratories are used for welding practicum activities that have a high level of risk, such as exposure to heat, sparks, light radiation, welding fumes, and potential fire. Ergonomic poster regarding the welding position when welding is installed. The need for fire extinguishers based on an area of 118.08 square meters is 1 unit and is available in dry chemical powder, placed on the wall next to the main door with a height of 120 centimeters from the floor without a marker, with the last maintenance recorded on November 7, 2024. P3K boxes are not yet available in this laboratory, although practicum activities are directly related to high-risk hot work. The PPE available is only in the form of a welding hood, without body, hand, breathing, or hearing protection.

The most significant finding was found in the Welding Laboratory, which despite having the highest level of risk among all laboratories observed due to exposure to heat, sparks, light radiation, and welding fumes, provided only a welding hood as the only type of PPE. The absence of wearpacks or aprons, heat-resistant gloves, respiratory masks, and hearing protection in these high-risk laboratories indicates a significant gap between the level of activity risk and the level of protection available. In general, the pattern found in the PPE aspect shows that the provision of PPE is not fully based on the specific risk assessment of each

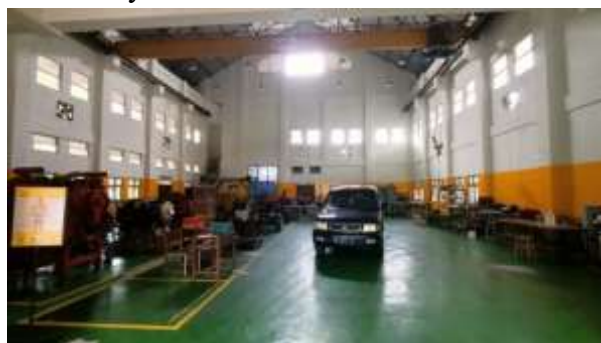
Figure 13. Laboratory of Mechanical and Industrial Equipment

The Laboratory of Mechanical and Industrial Equipment is used for practicum operation of industrial machinery and mechanical equipment, with potential hazards in the form of the risk of pinching, cutting, noise, and vibration. PPE posters are already available in the laboratory work area. The need for fire extinguishers based on an area of 388.8 square meters is 3 units, while what is available is only 1 unit, placed on a table next to the main door without a sign. P3K boxes are available in plastic cabinets that are in good condition and in accordance with standards in terms of physicality, but only contain red medicine and are installed at an angle so that they do not meet the requirements of function, security, and ease of access. PPE is not available at all to laboratory users.
